SB3/2023

Serious passenger injury on board a sea safari rigid inflatable boat

MAIB SAFETY BULLETIN 3/2023

The Marine Accident Investigation Branch is carrying out an investigation into a serious passenger injury on board a sea safari rigid inflatable boat.

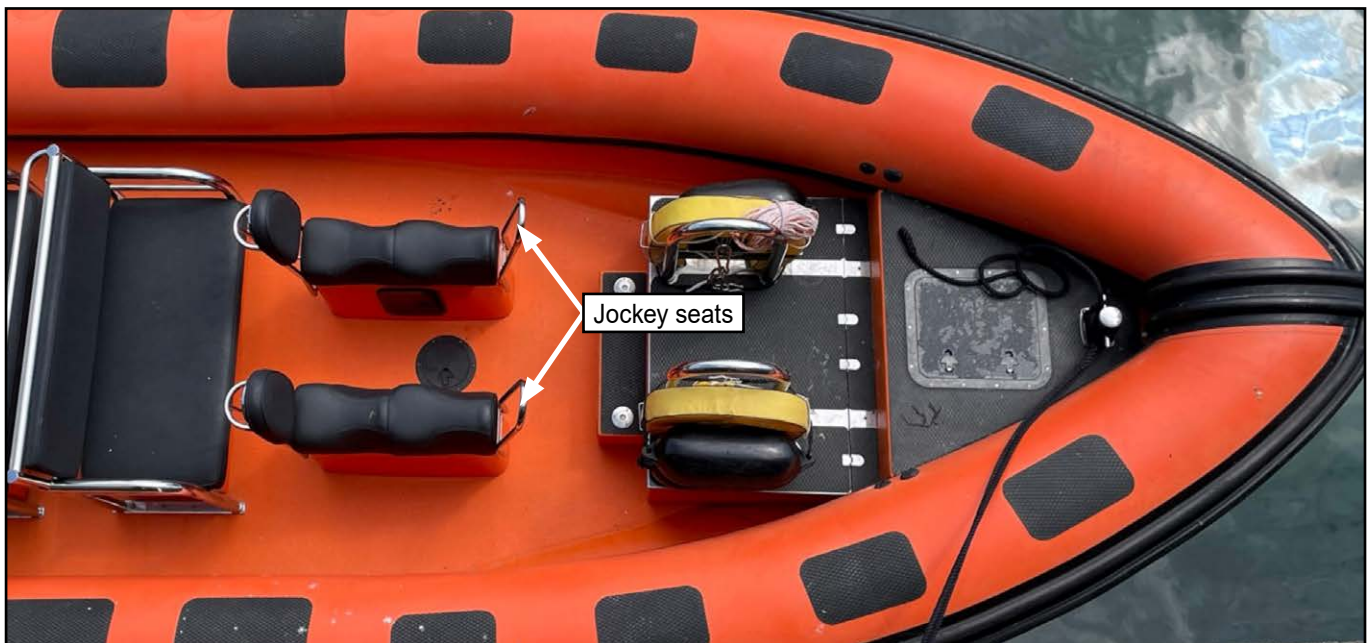
Figure 1: Front of RIB with jockey seats

On 7 June 2023, a passenger on a rigid inflatable boat (RIB) sea safari suffered a spinal injury that left them paralysed from the waist downwards. Twelve passengers had boarded the RIB and, once it was clear of the jetty, the two crew gave them a safety briefing and instruction on the wearing of lifejackets. The RIB then proceeded out to sea and was increasing speed in choppy sea conditions when it encountered a steep-sided wave. The boat fell off the wave and slammed violently into the trough, dislodging a passenger from a forward jockey seat (**Figure 1**). The passenger immediately lost feeling in their legs.

When the boat hit the trough, the resulting force applied to the passenger's spine was of sufficient magnitude to fracture a vertebra. With a normal BMD level and no pre-existing conditions to increase their susceptibility to this type of injury, the factors contributing to the fracture related to the activity being undertaken. These included:

- the speed and movement of the RIB in the sea conditions
- the forward location of the seat that the passenger was using
- the passenger's seated posture and their ability to react and compensate for the RIB's motions
- the passenger's awareness of the hazards associated with the RIB's movement.

- Urgently review their operations and risk assessments, with reference to the CoP and MGN 436 (M+F). This review should assess and mitigate the risks associated with the requirement to seat passengers in the front area of a RIB and ensure that the risk assessment includes and addresses the variability of weather conditions and the ability of passengers.
- Review their passenger pre-departure briefing and ensure that it includes a specific explanation of how to use the seat(s) and their associated handholds, including how to maintain the correct posture and stability to mitigate against injury.
